“Warped” is a term often (mis)used to describe any number of conditions associated with brake pedal pulsations, steering wheel shimmy, judder or any other vibrations that occur while applying the brakes.

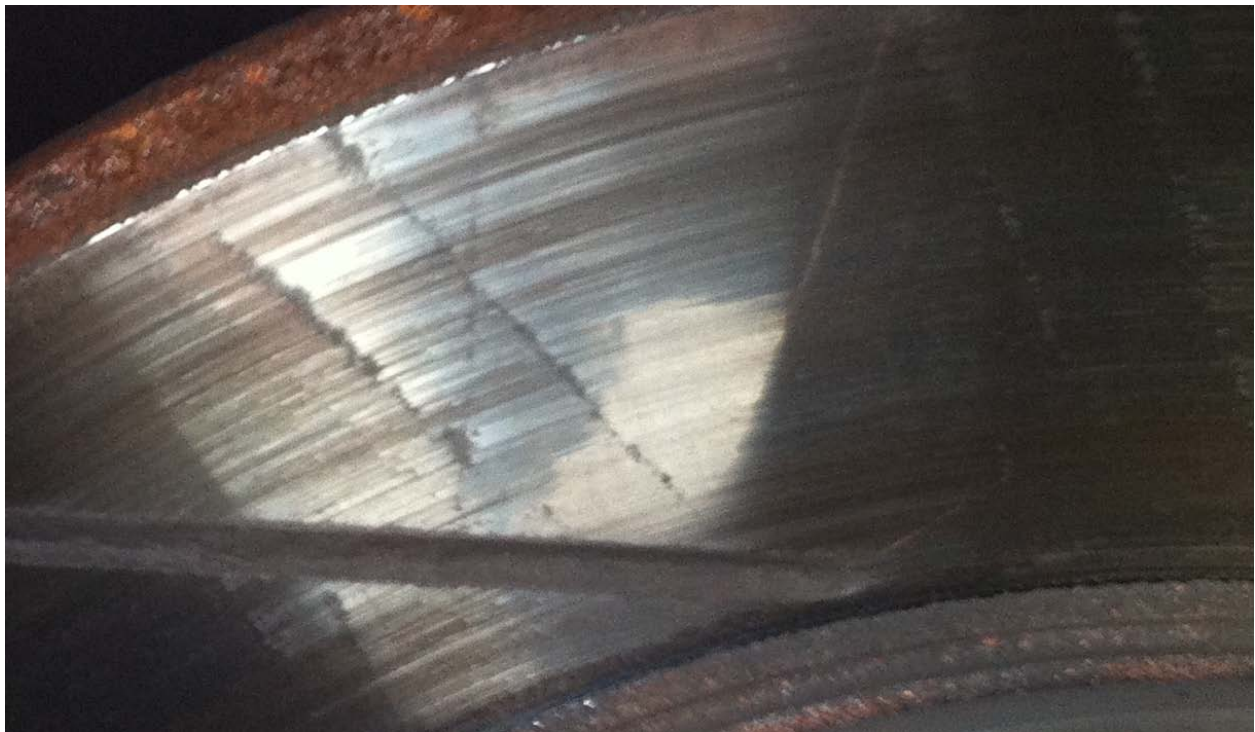
Image 1:

2: Corrosion. More common in areas where road de-icing chemicals are used, but not unheard of in other environments as well, especially where vehicles are not used on a regular basis, corrosion can

attack the brake rotor friction surface, degrading the friction transfer layer. Corrosion, in many cases will not occur to the same extent on the exposed portions of the rotor and the portion shielded by the brake pads when the vehicle is parked....resulting in somewhat degraded friction transfer layer on the majority of the rotor surface and a fairly protected transfer layer on the portion that was covered by the brake pads. The “sticky” spot on the rotor will create a greater level of friction every time it passes through the pads, causing the steering wheel to vibrate back and forth while applying the brakes. Minor cases, before surface damage has occurred to the rotor, will generally solve themselves by simply driving the vehicle...the pads will clean up the rotor surfaces. In more severe cases, the problem will continue to get worse as the vehicle is driven. Pitting will usually be visually evident on the rotor surface, along with evidence of where the edges of the brake pad contacted the rotor while the vehicle was sitting. Image #1 shows a fairly severe case of this, while image #2 shows a fairly minor, but still annoying case of this.

The only solutions in this case are to replace or machine the rotors, along with measures to prevent the occurrence of corrosion (drive the car more often, store in a garage, etc...). A more abrasive brake pad will also aid in keeping the rotor surface clean in particularly corrosive conditions.
